# GLEASON LIBRARY STUDY

## Existing Conditions & Treatment Recommendations

Prepared for the:  
**Town of Carlisle**

### Existing Conditions Report, Treatment Recommendations and Maintenance Priorities for the Gleason Public Library

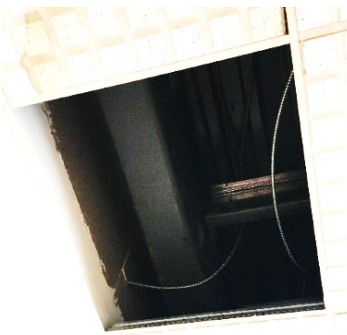
*View of Beams and Decking in Addition*

five inch floor slab, which sits on six inches of compacted gravel. The slab is covered in carpeting and cannot be seen. From what we could observe, the floor slab does not show any signs of settling or cracking. The only place where we observed damage to the slab is inside the egress area of the stairwell in the rear of the building. The upper floor of the addition (at the level of the first floor of the original building) is framed with steel beam with steel decking and a poured concrete floor. We were able to see a glimpse of it when one of the ceiling tiles was removed. It appears to be in good condition.

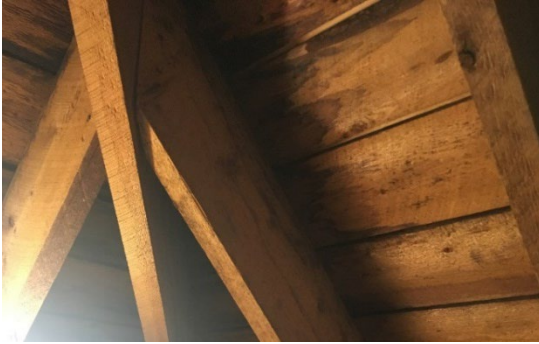
*Rafter and boards of original roof seen from attic in original building.*

The slate roof was significantly restored and repaired in 2010, during the Envelope Restoration and Repair Project. At that time, the slate shingles were removed, the disintegrated weather barrier was removed (felt), and damaged roof decking was replaced.

A new weather barrier was installed and original shingles in good condition were reused, others were replaced. Although staining can still be seen from the interior (not shown here), this is likely from water infiltration from over ten years ago, before the entire envelope was repaired. No dampness was observed now.

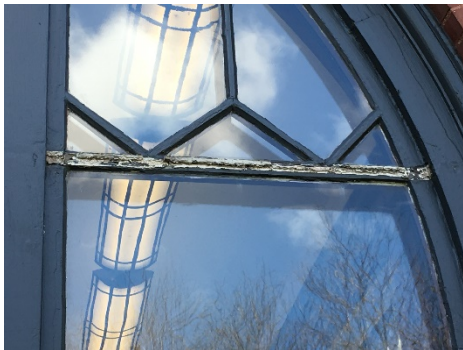
**Original Building:** In the original building the window and door heads and jambs are trimmed in wood, which are in fair condition overall. The window sashes are wooden and have interior storm windows attached. On some exterior window sashes the glazing has separated from the sashes, and the paint is peeling. On one front window one of the muntins has fallen off.

**2000 Addition:** All window frames, which are all metal, appear to be in good condition and housing operable windows. We note that there are openings in the corner miter joints. We note that there are no weep holes between the bottom of the window frame and the sill is sealed with caulk. The sashes appear to be in good condition and operating.

**Original Building:** The windows in the original building need to be restored. The glazing putty has dried out and should be tested for asbestos and abated if necessary, before any work begins. The window sashes and frames should be reglazed, scraped, primed and repainted. The interior storm windows that do not open but which are made to be operable should be fixed. The original building lacks access to fresh air, affecting indoor air quality.
